TOWNSHIP OF PUSLINCH 2019 Bridge and Culvert Inspections

Overall Summary

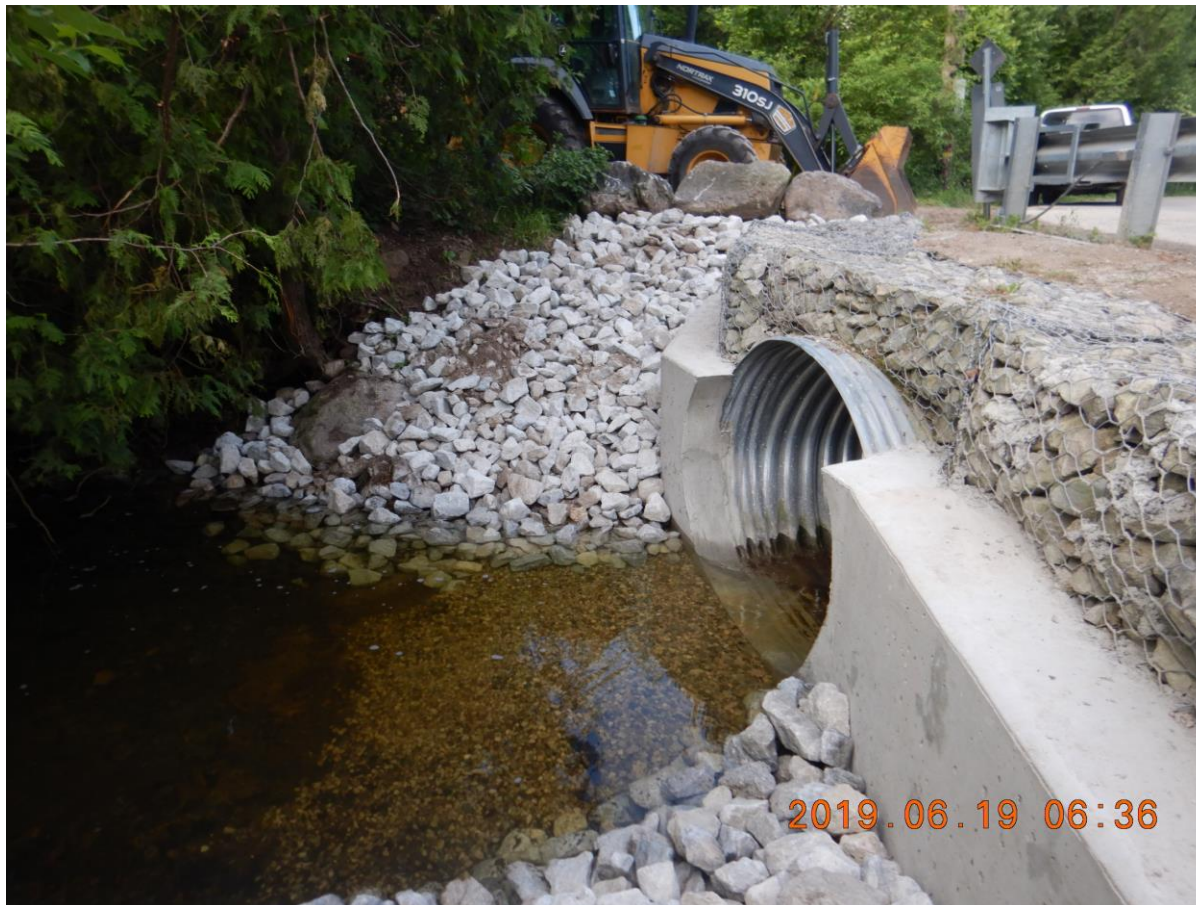
Mill Race Culvert (Structure 2002) (cont.)

- A sinkhole was discovered by Township staff in April 2019 on the west shoulder of the road
- As the OSIM inspection was completed in April, work was recommended for completion in less than 1 year to address the sinkholes and flow of water through the gabion headwall
- Drexler Construction completed repairs to the sinkhole, exploratory test holes to determine limits of undermining and repairs to the upstream gabion headwall to mitigate future erosion and undermining potential
- Work was completed in June 2019

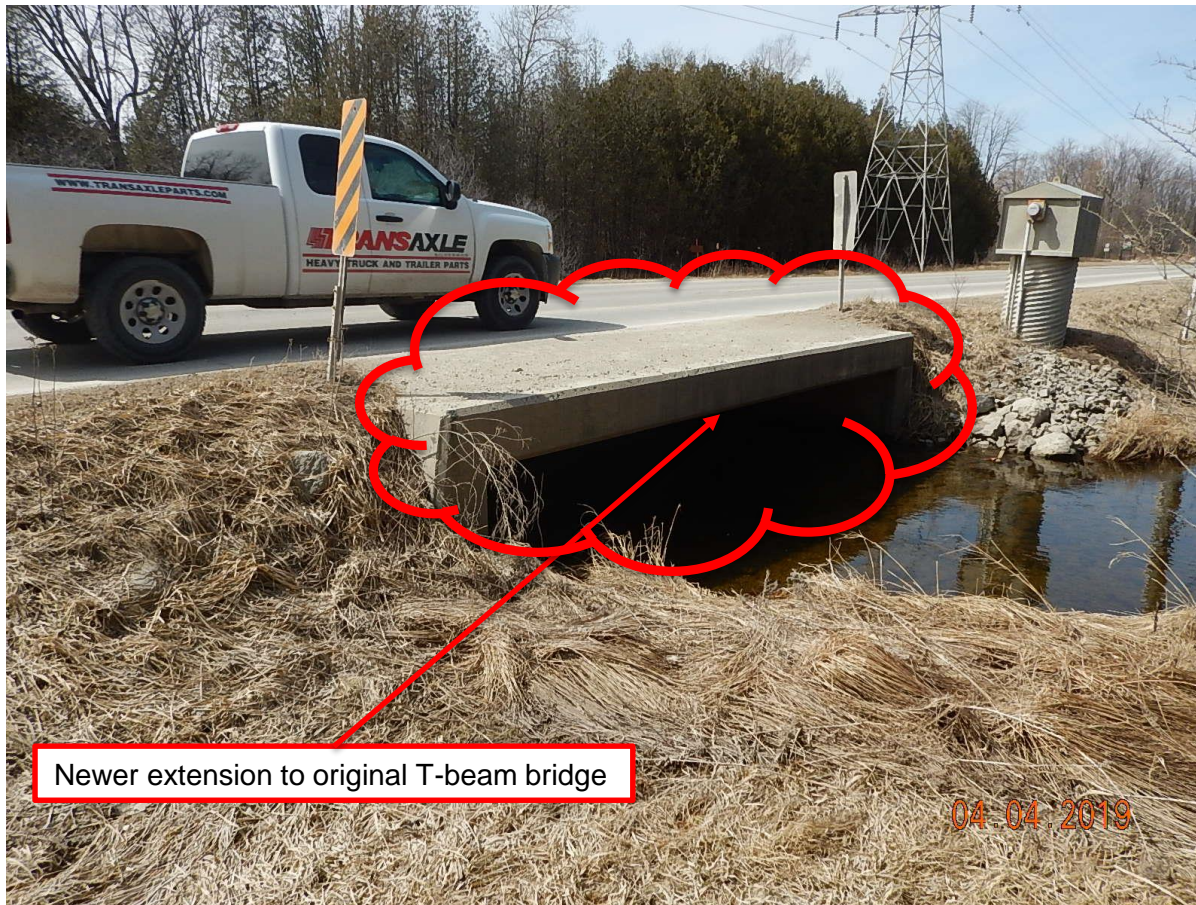
Moyer's Bridge (Structure 0004) (cont.)

- 6.1 m span concrete T-beam bridge built in approximately 1931, with newer concrete extensions on each end (construction date unknown)
- Last rehabilitation was in 2012 and included repairs to the concrete deck, soffit and T-beam for \$58,000 + HST
- This structure sees heavy truck traffic from adjacent gravel pits, an asphalt plant and the industrial park
- It is unlikely that additional repairs to the concrete T-beams would appreciably extend the useful life of the structure
- Replacement of the structure is recommended

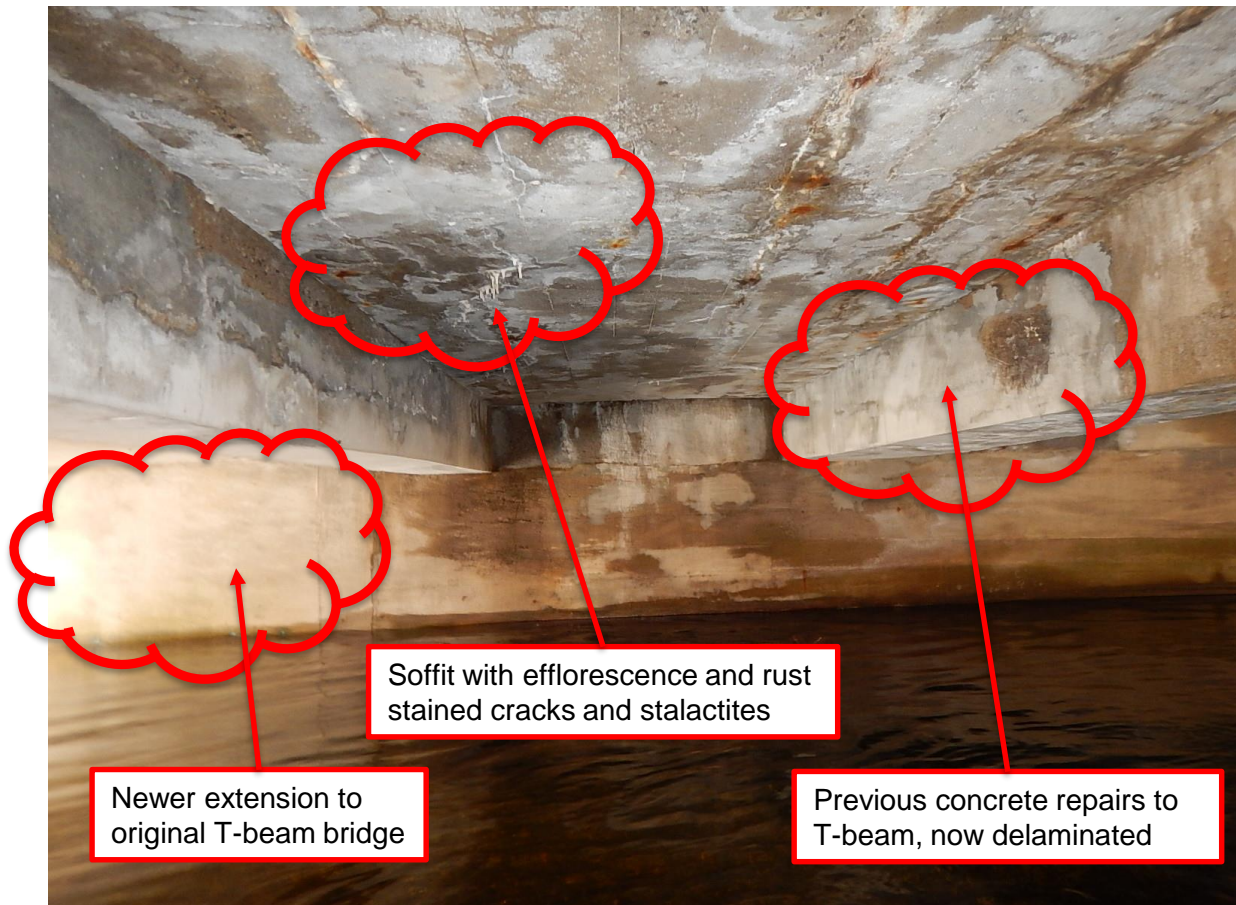
Moyer's Bridge (Structure 0004) (cont.)

Soffit with efflorescence and rust stained cracks and stalactites

Newer extension to original T-beam bridge

Previous concrete repairs to T-beam, now delaminated
