THE CORPORATION OF THE TOWNSHIP OF PUSLINCH  
July 16, 2019 SPECIAL COUNCIL MEETING

## 2019 Bridge and Culvert Inspection Summary Report

GMBP File: 119050

June 2019

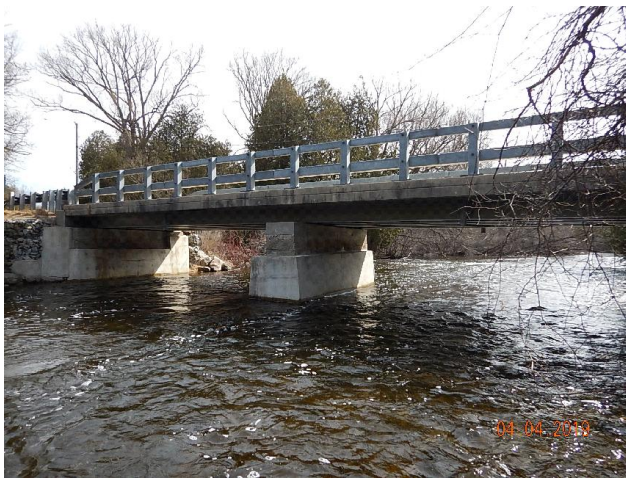
Structure: 0001

## Cook's Mill Bridge

Bridge Condition Index (BCI): 69

| <u>Element</u> | <u>Need</u> | <u>Priority</u> | <u>Description</u> |
|---|---|---|---|
| Decks - Deck Top | Bridge Cleaning | | Clean off deck annually. |
| Joints - Seals/Sealants | | | Clean debris from joints annually. |

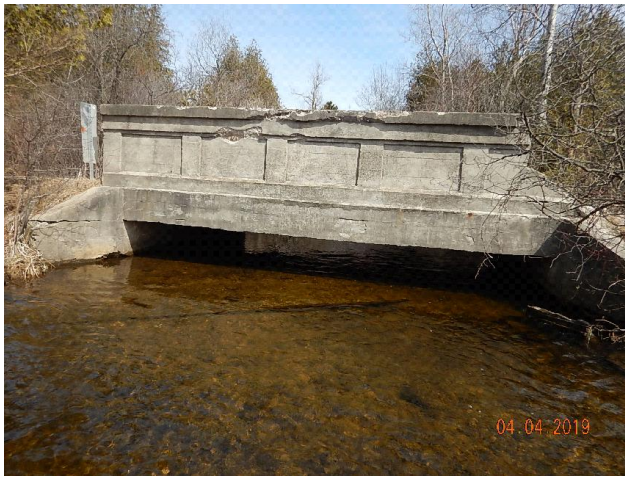
Structure: 0003

Structure 0003 (Little's Bridge) is located on Sideroad 25 North, 200 m south of Concession Road 7. The structure is a concrete rigid frame bridge with concrete parapet barriers. The barriers of the bridge are in very poor condition, and sagging is apparent in the deck slab. This bridge has a very low AADT, and services only one property (Slovenski Park).

Previous recommendations for this structure have included rehabilitation of poor concrete areas and barrier replacement in the 1 to 5 year time frame, and consideration of structure replacement. Upon review of this structure and the surrounding area, it was noted that there exists the possibility of abandoning the existing bridge and constructing a new driveway access to Slovenski Park south of Mill Creek. This would require property acquisitions by the Township, but would alleviate the need for a costly structure rehabilitation and ultimately replacement. It is estimated that the construction of a gravel driveway entrance to Slovenski Park south of Mill Creek would cost \$200,000+HST. This cost does not include property acquisitions.

This structure is subject to a 10 tonne load limit. The scope of the rehabilitation provided on the OSIM report does not account for works to remove the load limit. It is unlikely that a rehabilitation to remove the load limit would be economically practical as compared to replacement. Replacement of the structure is estimated to cost approximately \$500,000+HST.

## Little's Bridge

| <u>Element</u> | <u>Need</u> | <u>Priority</u> | <u>Description</u> |
|---|---|---|---|
| Embankments & Streams -<br>Streams and Waterways | Bridge Cleaning | | Trim/remove excess vegetation. Remove fallen tree. Remove pieces of concrete barrier (both sides). |

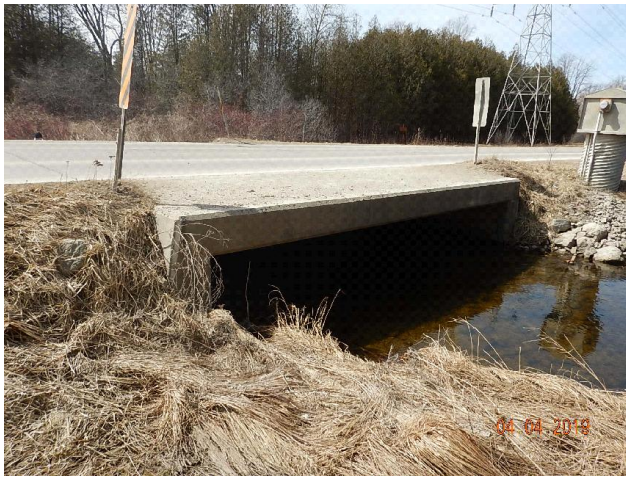
Structure: 0004

Structure 0004 (Moyer's Bridge) is located on Concession Road 7, 1.0 km south of Wellington Road 34. The original structure is a concrete T-beam bridge which has since been extended with cast-in-place concrete extensions (date of construction unknown). Overhead concrete repairs to the original T-beam structure, waterproofing and resurfacing works were completed in 2012.

Although the newer concrete extensions are in good condition, the original T-beam structure is in poor condition. Several delaminated areas are still present, even in the areas repaired in 2012. We believe that this is likely due to a high chloride concentration in the concrete from years of road salting causing corrosion of the steel reinforcement. It is also noted that this structure carries a large amount of heavy truck traffic. Our experience is that shallow overhead concrete patch work can be expected to last anywhere from 5 to 15 years.

If additional concrete repairs were to be completed to the existing T-beam structure, they would not be anticipated to appreciably extend the useful life of the structure. Therefore, replacement of the entire structure has been recommended

in 1 to 5 years. Alternatives to replace the existing structure while keeping the extensions could be explored to reduce capital costs.

## Moyer's Bridge

| <u>Element</u> | <u>Need</u> | <u>Priority</u> | <u>Description</u> |
|---|---|---|---|
| Approaches - Wearing Surface | Bridge Surface Repair | | Repair pothole. |

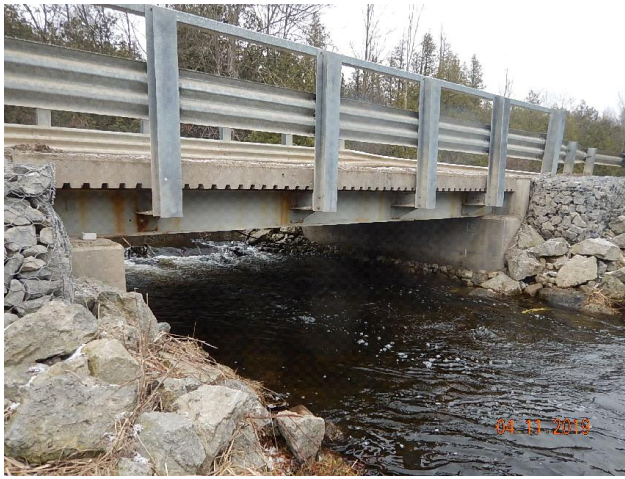
Structure: 0007

## French's Bridge

| Element | Need | Priority | Description |
|---|---|---|---|
| Embankments & Streams - | Other | | Clear debris build-up. |
| Streams and Waterways | | | |

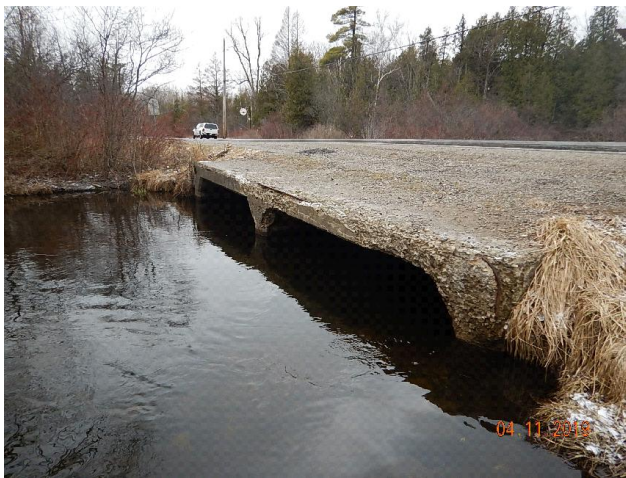
**Structure: 0008**

Structure 0008 is located on Gore Road, 200 m east of Shellard Side Road. The structure is a two-span concrete rigid frame structure. The ends of the structure are in poor condition with areas of severe disintegration, erosion and spalling; however, the interior of the structure appears to be in fair to good condition. Deterioration of the structure will continue to progress to the interior barrels of the structure as repairs are delayed.

Concrete repairs, waterproofing and resurfacing are recommended to the structure in 1 to 5 years in order to extend its useful life. Due to the lack of cover on the structure, the Township may also wish to consider concrete curbs and asphalt spillways to limit the chloride exposure of the exposed ends. This concrete curb and asphalt spillway work has not been included in the scope of work detailed on the OSIM form.

| <u>Element</u> | <u>Need</u> | <u>Priority</u> | <u>Description</u> |
|---|---|---|---|
| Accessories - Signs | Other | | Install hazard markers. |
| Embankments & Streams -<br>Embankments | Erosion Control at Bridges | | Install erosion control at embankments. |

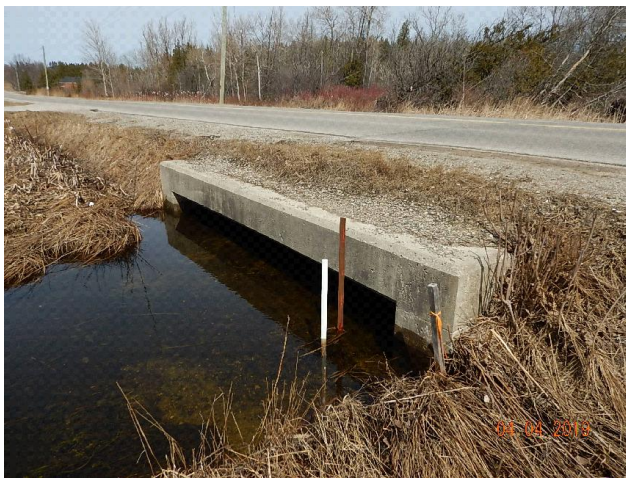
Structure: 2006

## Culvert over Galt Creek

| <u>Element</u> | <u>Need</u> | <u>Priority</u> | <u>Description</u> |
|---|---|---|---|
| Accessories - Signs | Other | | Install hazard marker at structure. |

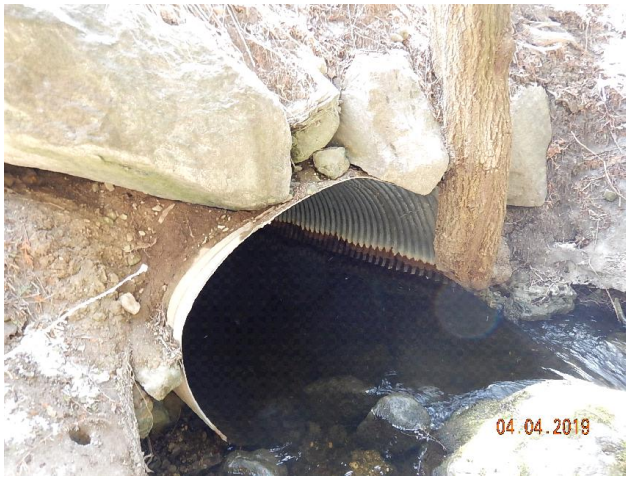
Structure: 2009

## Culvert over Aberfoyle Creek

| Element | Need | Priority | Description |
|---|---|---|---|
| Embankments & Streams - Embankments | | | Stabilize slopes, remove large rocks and trees. |
| Embankments & Streams - Streams and Waterways | | | Remove rocks blocking channel flow. |

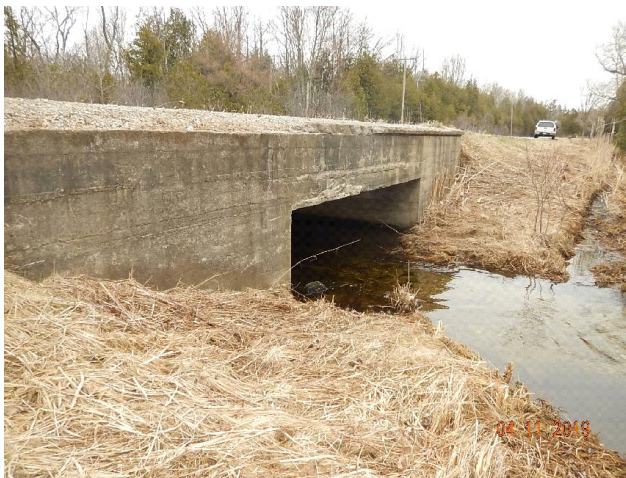
Structure: 2010

Structure 2010 (Ellis Road Culvert over Irish Creek) is located on Ellis Road, 800 m west of Wellington Road 32. The original structure is a concrete open-footing bridge, and there is a newer concrete open-footing culvert extension on the north end. The original structure was built in approximately 1920, and exhibits severe delamination, spalling and erosion with exposed corroded rebar. The extension to the north is in good condition.

In May 2017, the top of the culvert on the original structure was exposed and found to be good condition. The surface was chain dragged and hammer sounded, with no areas of delaminated concrete noted. One small area of spalled concrete was noted on the southeast corner of the bridge deck, and one full width longitudinal crack running from the east to west was noted. The defects did not appear to be of immediate concern. Given the size of the original culvert, repairs may not be a cost-effective way to extend the life of the structure. Therefore, the original structure has been recommended for replacement in the next 6 to 10 years.

We note that this work may be able to be delayed beyond the next 10 years, pending future biennial inspections. We measured approximately 0.45 m of cover at the centreline of the road, and approximately 0.60 m at the south edge of the structure. This may allow for the construction of a new reinforced concrete slab over the existing culvert should its condition deteriorate before the Township can fund a replacement of this section.

## Ellis Road Culvert over Irish Creek

| <u>Element</u> | <u>Need</u> | <u>Priority</u> | <u>Description</u> |
|---|---|---|---|
| Accessories - Signs | Other | | Three (3) additional markers required. |
