THE CORPORATION OF THE TOWNSHIP OF PUSLINCH  
July 16, 2019 SPECIAL COUNCIL MEETING

## 2019 Bridge and Culvert Inspection Summary Report

GMBP File: 119050

June 2019

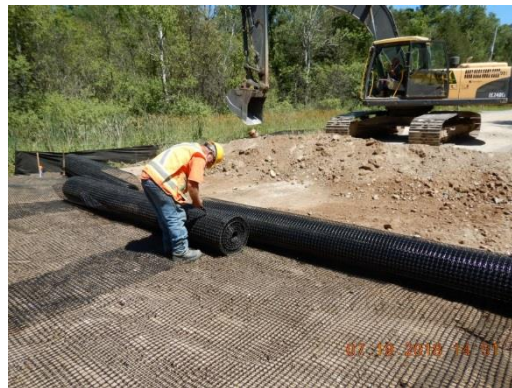
Figure 2: Installation of Biaxial Geogrid between Subgrade and Subbase

Refer to Figure 2 below for a photo of biaxial geogrid installed on a Township road in 2018. In this instance, the biaxial geogrid was used to reduce the required thickness of granular subbase over a poor native subgrade material.

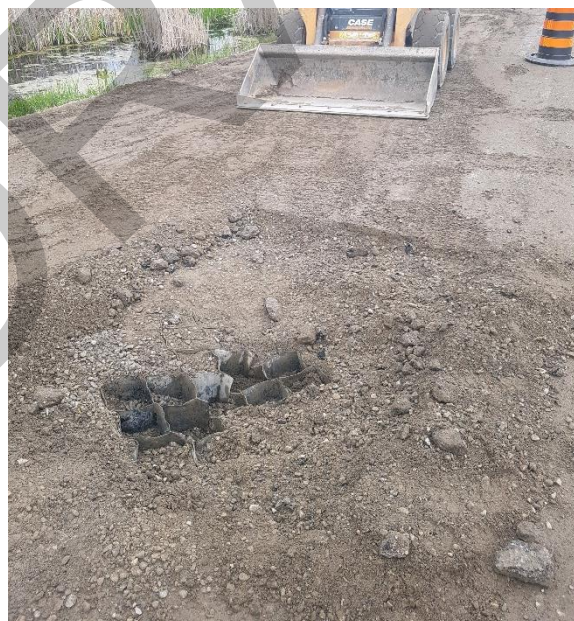
Figure 3: Installation of Cellular Confinement System overtop of Poor Subgrade

Refer to Figure 3 below for a picture of a cellular confinement system installed on a Township road (original date of construction unknown). In this instance, the cellular confinement system was used overtop of a poor subgrade material.
